# Weakened Roof Assemblies: An Analysis of Safe Home Grant Applications

Prepared by:  
Matthew A. Hawkins

## Weakened Roof Assemblies: An Analysis of Safe Home Grant Applications

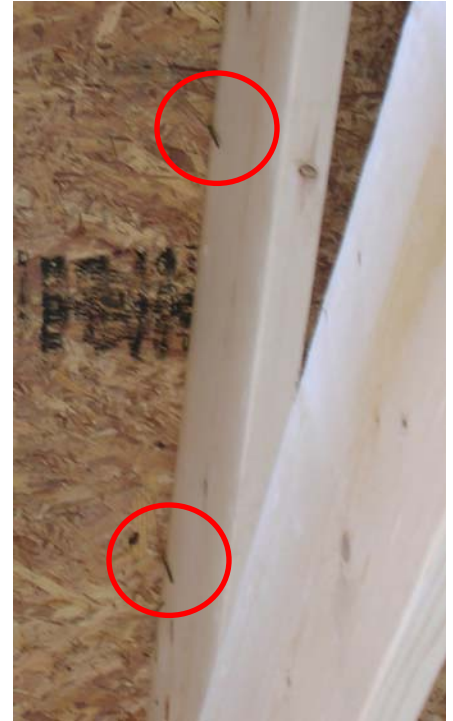
Picture of nails missing the truss

If the nails were attached with a spacing of one nail every 6", a 4' section will have a total of 8 nails, while a nail spacing of one every 3" will have a total of 16 nails per 4' section of sheathing-truss connection. For the ten homes averaging 2 or 3 missed nails per 4' section, anywhere from 12.5% to 37% of the total nails in the roof assembly will not be attached to a framing member, depending on nail spacing. While homes averaging 1 nail miss per 4' section will have between 6% and 12.5% of the nails not providing any wind uplift resistance to the roof assembly.

One of the wind inspectors recommended reattaching the roof deck because it "has the most number of missed nails I have ever seen" (Record #50). On this particular Home Survey Checklist the wind inspector noted the number of missed nails per 4' section was 3. This leads one to believe that other homes with 3, and even 2, missed nails per 4' section is a substantial number and these homes are very likely unprepared for the next high wind event.
